**State of Louisiana
Department of Natural Resources
Coastal Restoration Division and
Coastal Engineering Division**

**2005 Operations, Maintenance,
and Monitoring Report**

Lake Portage Land Bridge

State Project Number TV-17
Priority Project List 8

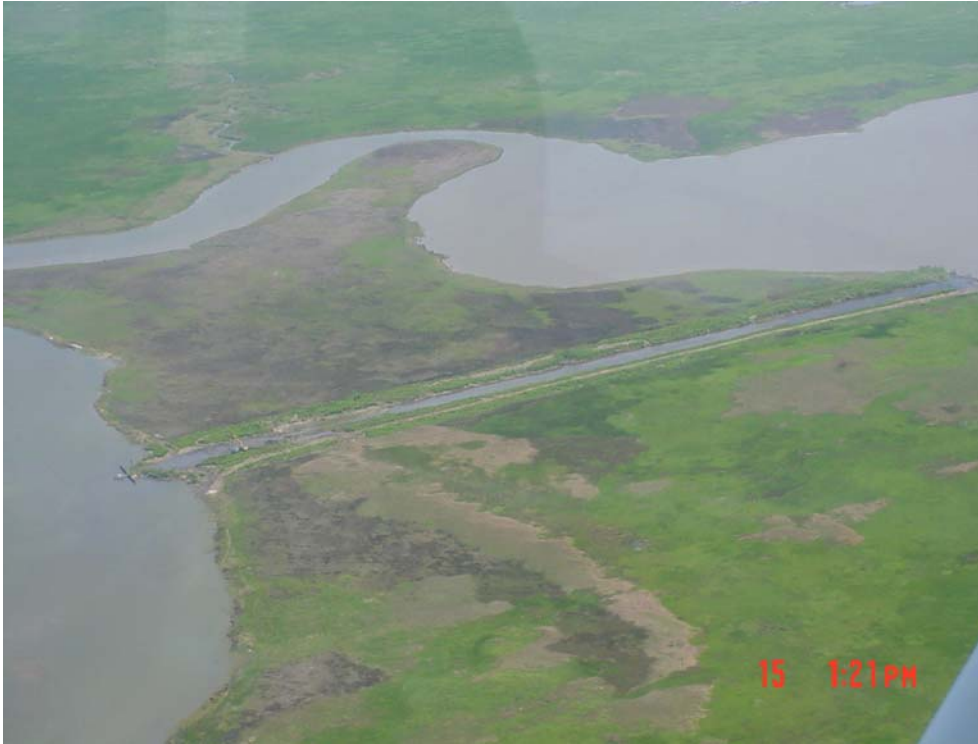
Figure 2. Aerial photograph (Area 3) taken before TV-17 project construction, showing the gas pipeline between Vermilion Bay (left) and Lake Portage (right).

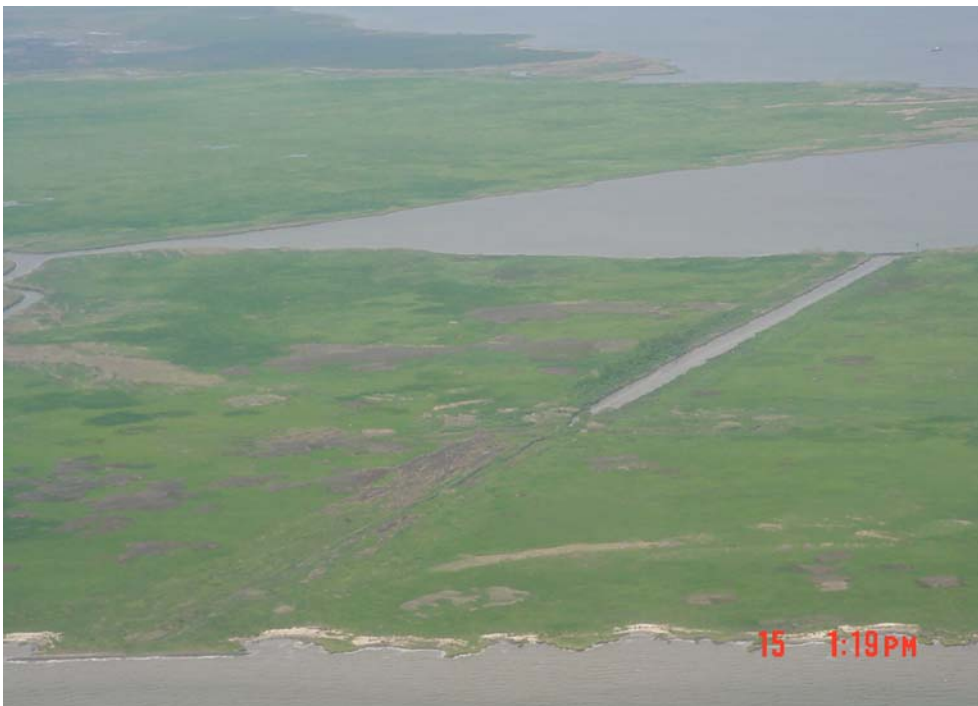
Figure 3. Aerial photograph (Areas 1 & 2) taken before TV-17 project construction, showing the gas pipeline between Lake Portage (above) and the Gulf of Mexico (below).

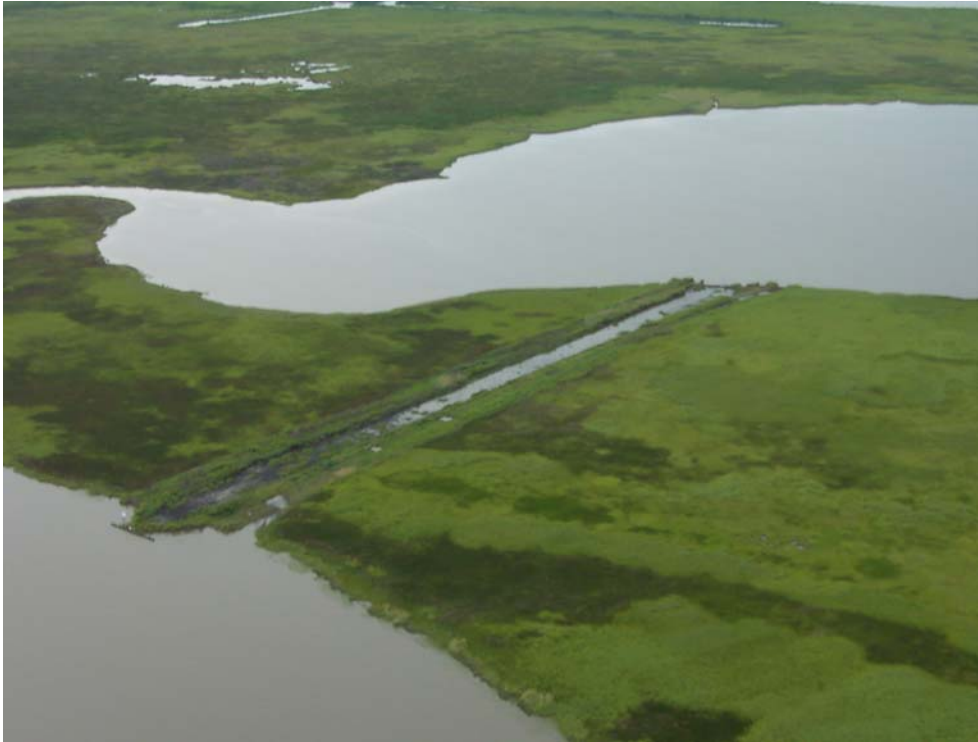
Figure 4. Aerial photography (Area 3) taken after TV-17 project construction, showing the gas pipeline between Vermilion Bay (lower left) and Lake Portage (upper right).

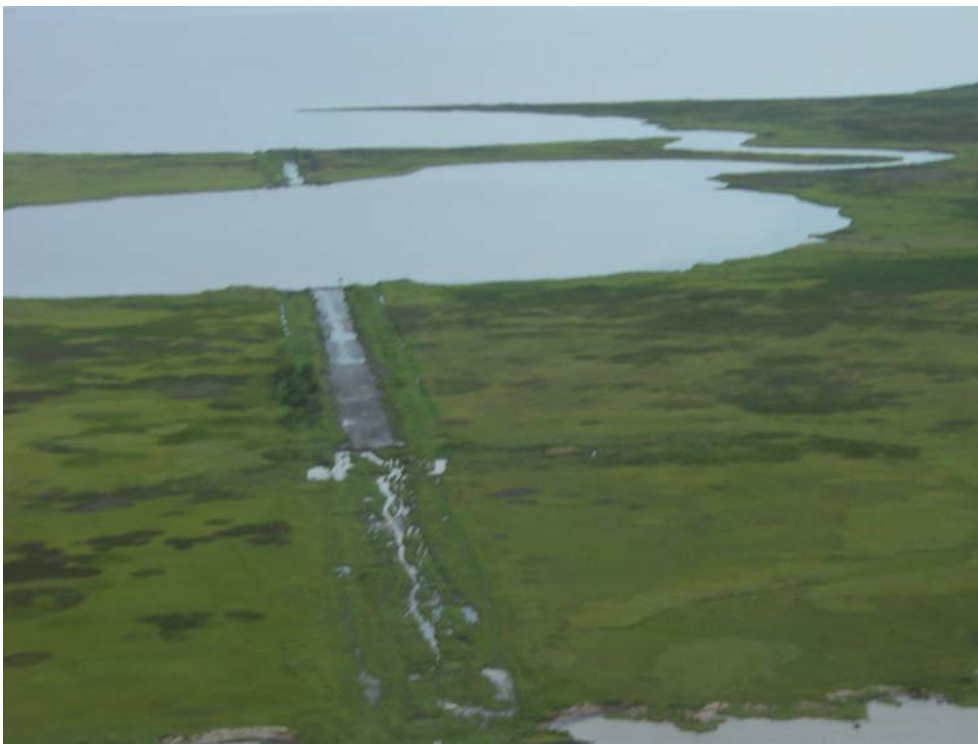
Figure 5. Aerial photography (Areas 1 & 2) taken after TV-17 project construction, showing the gas pipeline between Lake Portage (above) and the Gulf of Mexico (below).
